Intel[®] Xeon[®] Processor E3-1200 v6 Product Family

Specification Update

August 2019

Revision 019

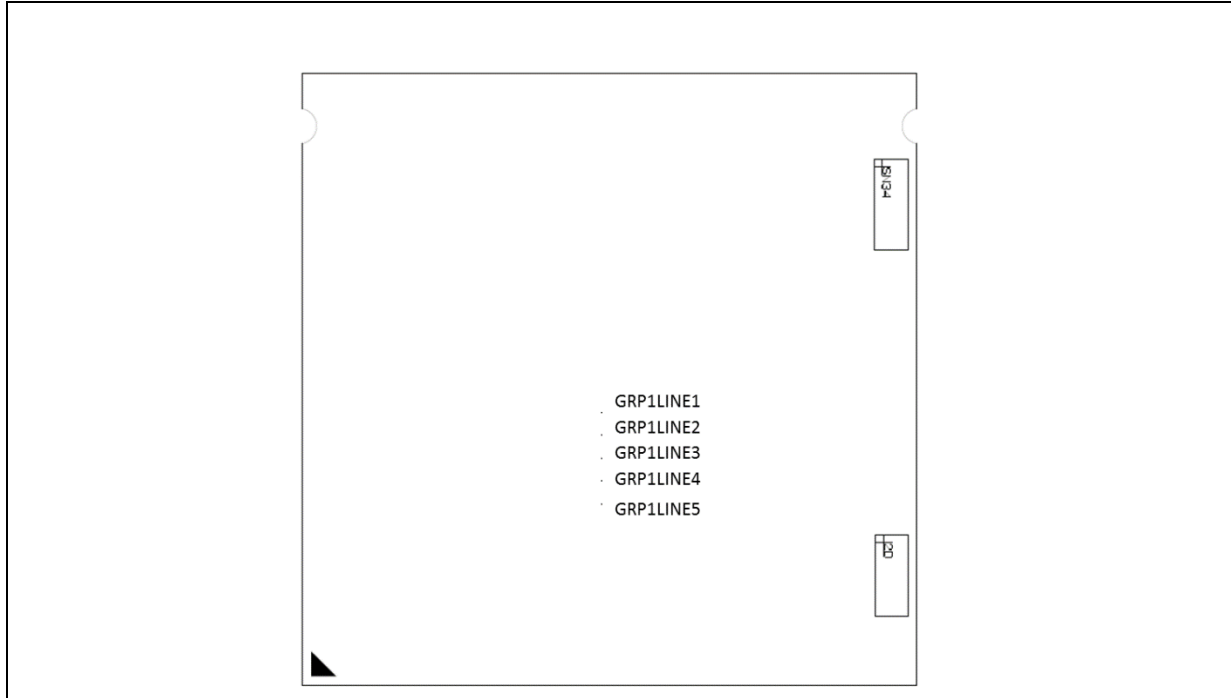
Figure 1. LGA Top-Side Markings

Pin Count: 1151

Package Size: 37.5 mm x 37.5 mm
